NORWICH BARN SURVEY 2021

NORWICH HISTORIC
PRESERVATION COMMISSION

LYSSA PAPAZIAN
HISTORIC PRESERVATION CONSULTANT
13 DUSTY RIDGE ROAD, PUTNEY, VT 05346
www.lyssapapazian.com ~ lyssa@lyssapapazian.com
(802) 536-5262 / (802) 579-3698 CELL

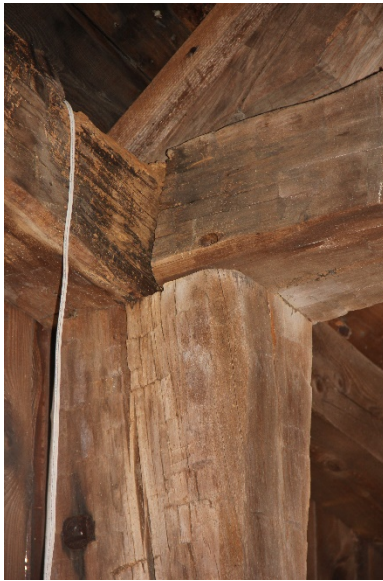
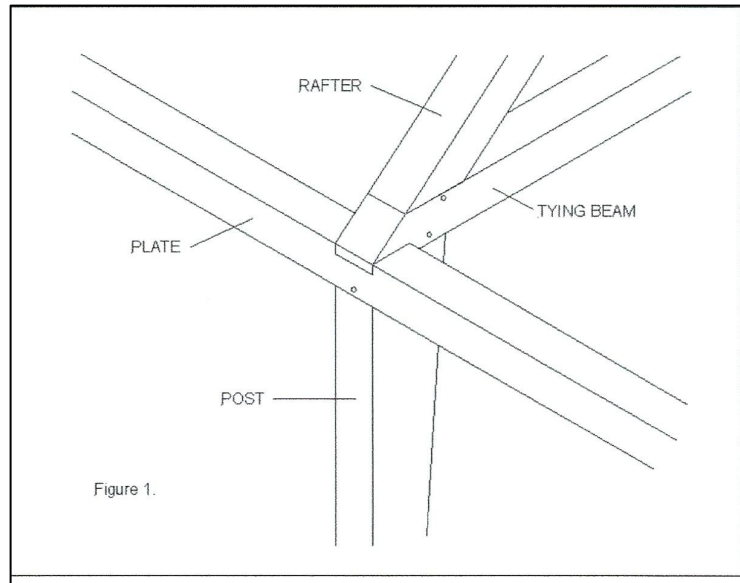
Top Left: example of English Tying Joint at 218 Dutton Hill Road; Top right: diagram of the joint from The English Barn in the New World/MAdisonbarns.wordpress.com

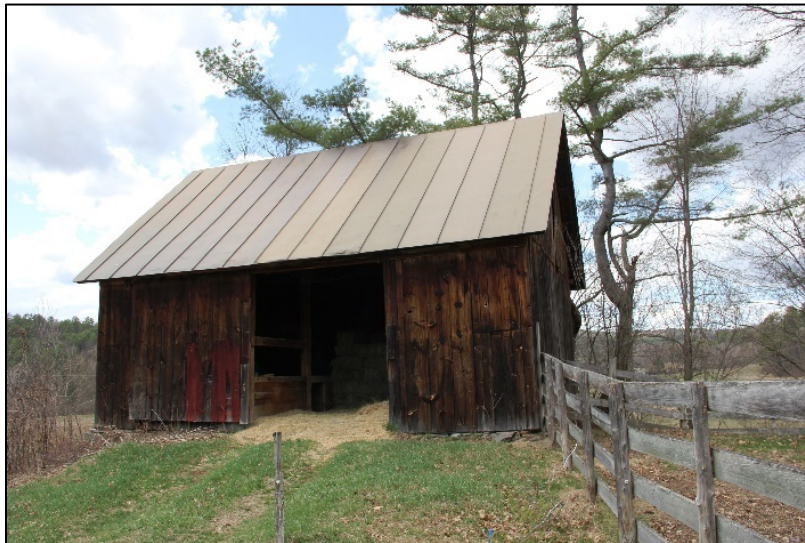
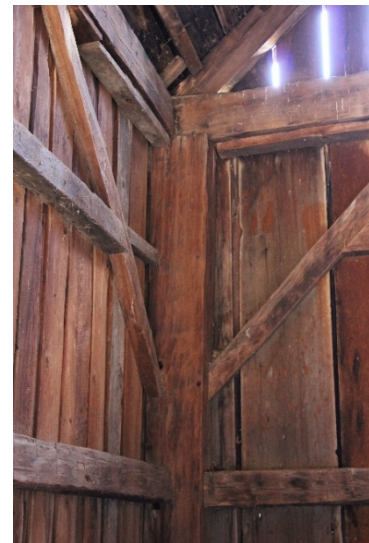
98 Campbell Flat Road: Bottom Left, entrance to former threshing floor; Bottom Right, gunstock post with English Typing Joint in 98 Campbell Flat Road

An excellent example of an early English style barn, that was likely later made into a bank barn, is at 98 Campbell Flat Road. Its roof framing of principal rafter with common purlins (rather than the opposite) is an early form that was found in Southern New England but not common in Vermont. The late eighteenth century, scribe rule frame is sophisticated using gunstock posts and the English Tying Joint which may indicate that it was made by itinerant professional framers, like Broughton and Carpenter. The framing of the manure basement level, has sawn timbers suggesting it was a later addition when the older barn was moved to a sidehill to create the lower floor.

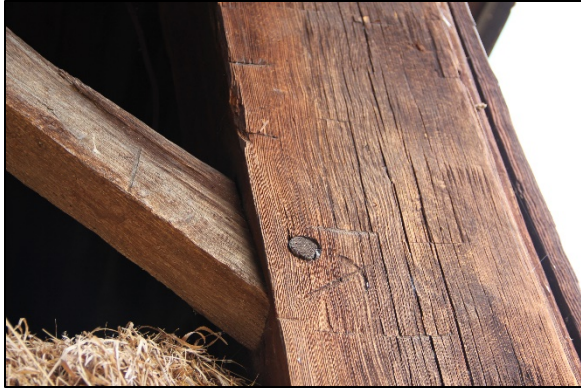
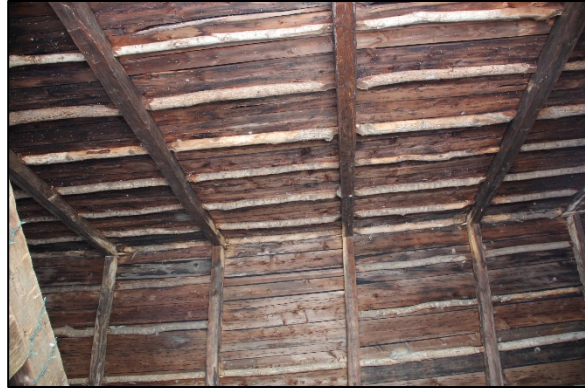
98 Campbell Flat Road: Left, scribe match marks on the frame; Right, principal rafters with common purlins pegged into them – an old style of roof framing uncommon in Vermont, but seen in Southern New England

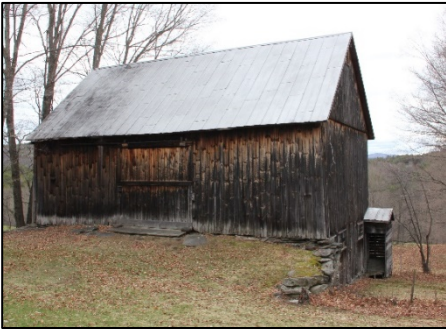
Top: Early (English) Bank barn at 211 Brigham Hill Road

The ca. 1830 small English Barn at 211 Brigham Hill Road has its original stone foundation. Another English sidehill barn is at 1280 Turnpike Road.

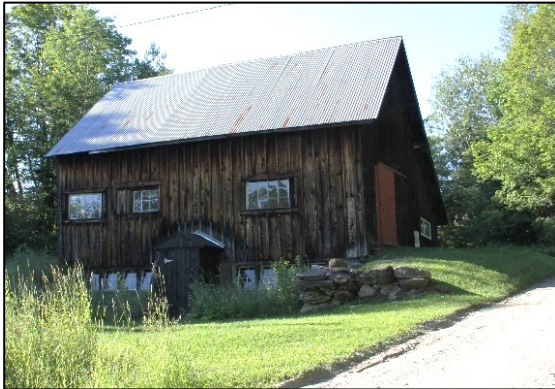
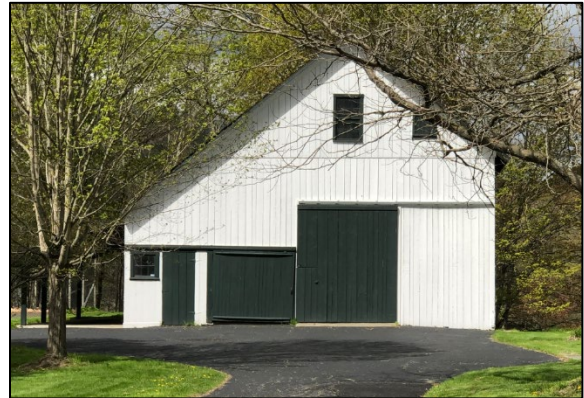
Center Left: Yankee style bank barn at 380 Chapel Hill Road; Center Right Yankee barn at 395 Main Street

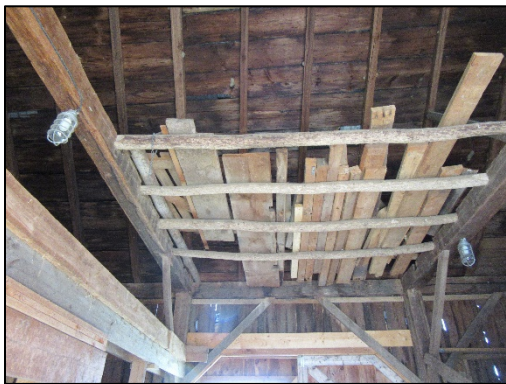
Bottom: 652 Patrell Road, example of a pole loft

At 652 Patrell Road, there are two early nineteenth century English Barns built and/or moved to be perpendicular with one a bank barn. The hay mow floor of the bank barn communicates with the upper hay mow level of the ground level barn. One has a good example of a pole loft that could be added or taken up as needed.

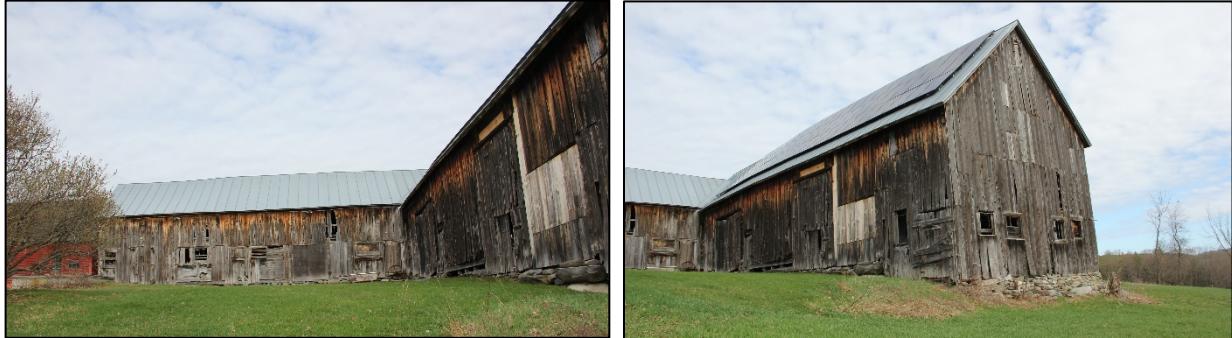
The created barnyard at 218 Dutton Hill Road with the extended English barns tied together. On the Top Left the barn straight ahead is one or perhaps two older English barns. On the Top Right, an older English Barn was extended a bay to the right (end of barn) and was extended and connected to the other English barn on the left of the view. Milking stalls were then created under the new extended end.

The four-bay extension also formed a corner connector to two older barns that seem to have been moved here and connected. This formed the large “L”-shaped protective barnyard that was more common in the later nineteenth century. The other older barns are fitted up with a farm shop, stalls, and whitewashed pens with a few wooden stanchions for dairy cows. The diversified operation described by farmer Paul Metcalf in his daily diaries of the 1930s was well served by the expanded arrangement of these barns which could accommodate a small number of different types of livestock, increasing hay production, and on-farm operations. Based on local sources, there was a set of barns across the road from the house that burned after a lightning strike. It was after this that the barns were thought to have been moved and rearranged.

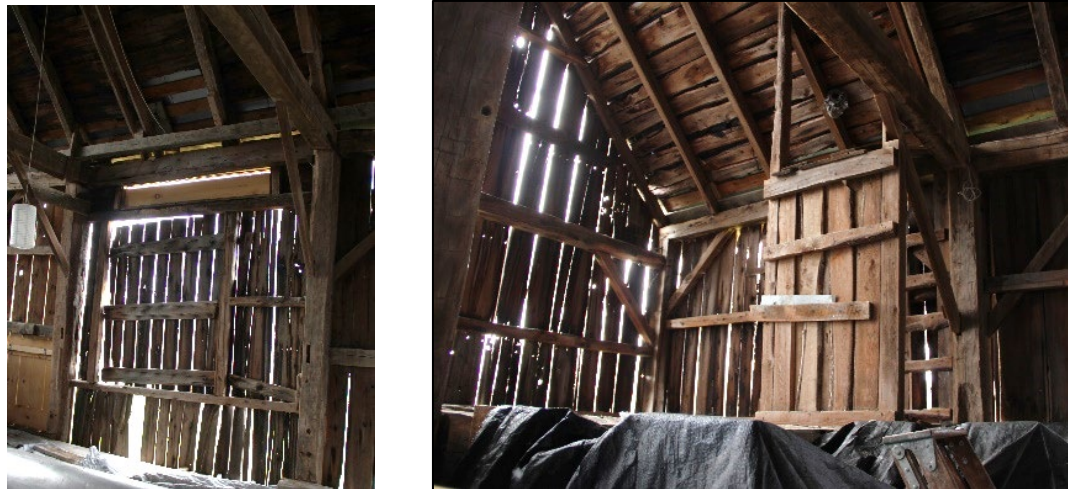
Bottom Left: The original central bay door with former transom opening of the early English Barn, infilled with later wall framing; **Bottom Right:** the large added end bay with built-in hay ladder coming up from lower level and wooden wall built to protect the access from loose hay. Note: a higher floor was built in the added bay to create a usable lower level. This suggests that the older barn was not re-located but the extension took advantage of a very slight bank near the original location.

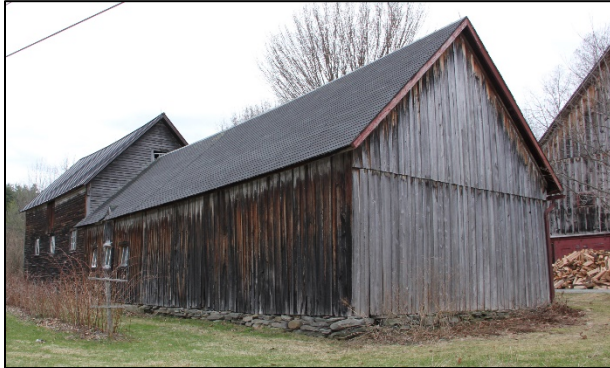
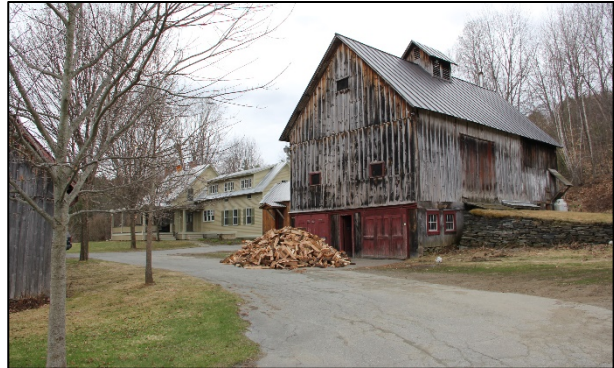
Top Left and Right: Connected barns and created barnyard at 15 Brigham Hill Road

Another early example of a complex of barns is at 15 Brigham Hill Road, in which a ca. 1875 banked barn with a ramped drive into the hay mow is at the center.

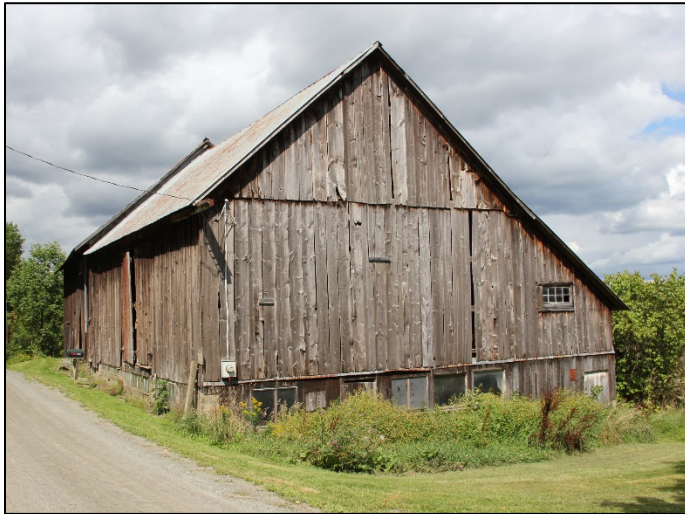
Older barns were brought together at a bank at 229 Bradley Hill Road (the barn is no longer extant). These appear to have been two English Barns end to end and likely relocated to the slope by the road. The line of siding change seen on the gable at the level of the road is an indication that it was likely not originally a bank barn. It was also extended on the rear to maximize the lower-level space.

Center: Former barns at 229 Bradley Hill Road in 2015

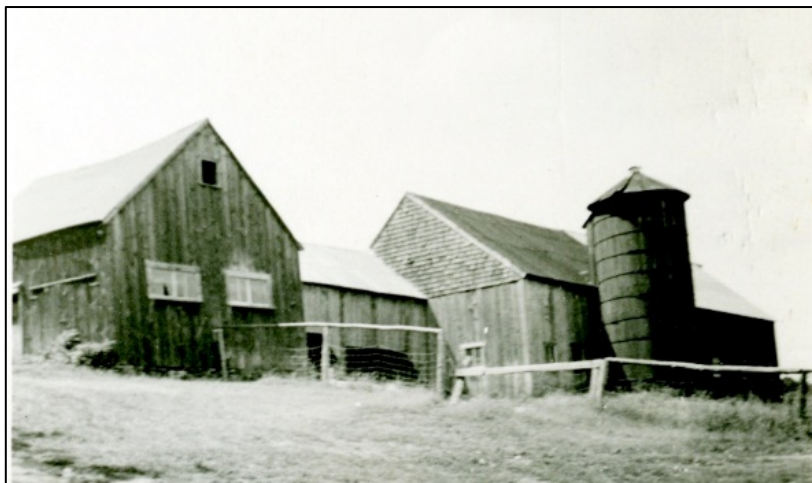
A collection of attached barns that are no longer extant are seen in a ca. 1950 lister photo at 136 Bradley Hill Road. There appear to have been an English bank barn, a Yankee bank barn and a connecting shed. Some of these barns burned and some fell down more than 30 years ago, according to present owner.

Bottom: ca. 1950 view of former barns at 136 Bradley Hill Road with silo

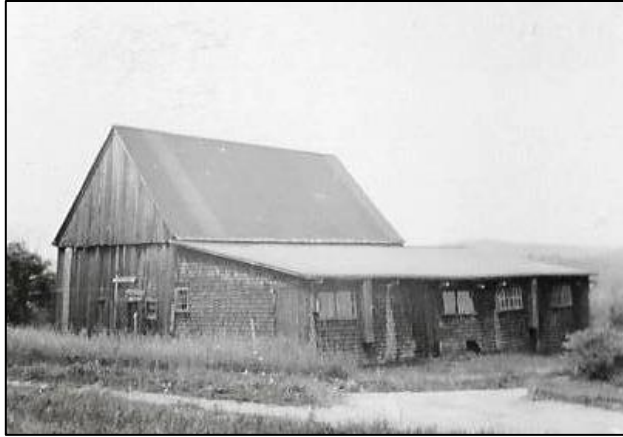
The use of an older English Barn was expanded with an addition at the intersection of Bowen Road and Waterman Hill Road. (The addition is no longer extant and the older barn has been restored.)

Top: ca. 1960 view of expanded older barn at 227 Waterman Hill Road

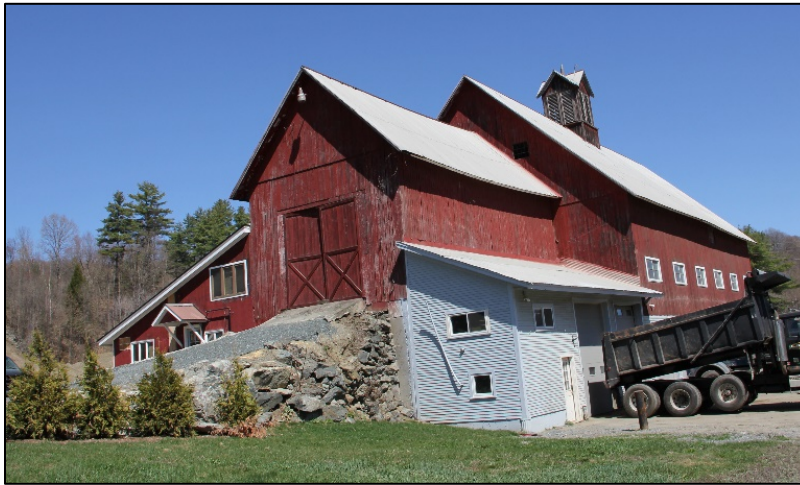
Top Left: High Drive bank barn at 287 River Road with stone abutment; Top Right: framing of the third level with upper loft platform.

cupola ventilator. It has its stable windows on the second-floor level that is accessed by an earthen ramp on the rear. On the front gable, its enclosed high bridge is almost a small barn in itself with a steep stone and earthen ramp that leads to its third-floor loft level.

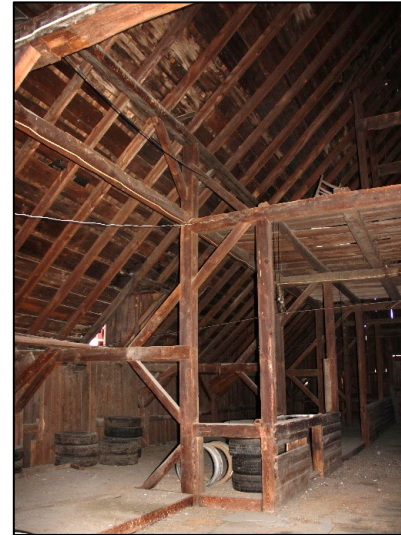
The dairy herd and horses would have been housed on the second-floor level and other livestock and bays for manure spreaders might have been on the ground floor level. This barn was adapted in the later twentieth century for larger machinery on the ground level by raising the whole frame and placing it on concrete posts.

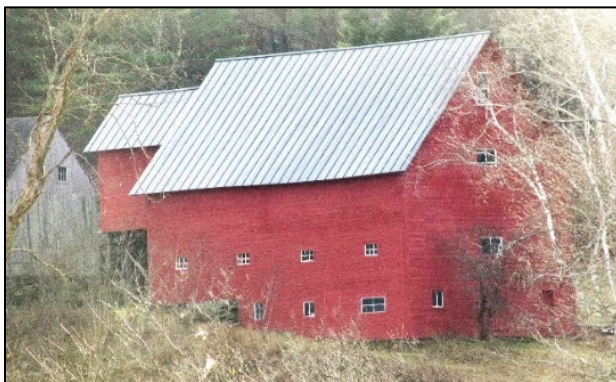
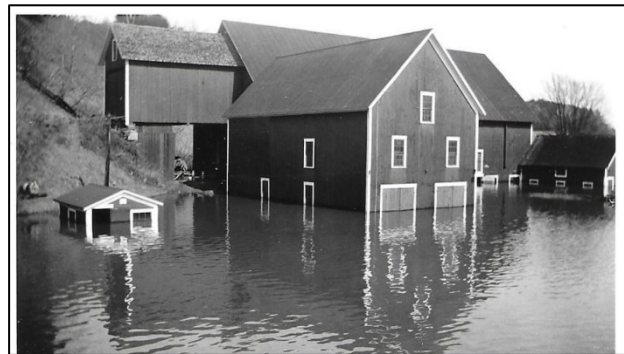
Two extant high drive barns are at 519 Bragg Hill Road (1902) and 304 Route 132 (ca. 1890s). They are three- and four-story bank barns, respectively. Another, seen in historic photos, was at the Waterman Farm, the remains of which are at 8 Old Bridge Road.

Bottom Left: 304 Route 132 from the rear showing all four of its levels; Bottom Right: Historic view of the high drive bridge barn at the Waterman farm (now 8 Old Bridge Road) during a major flood. Only part of these barns remain.

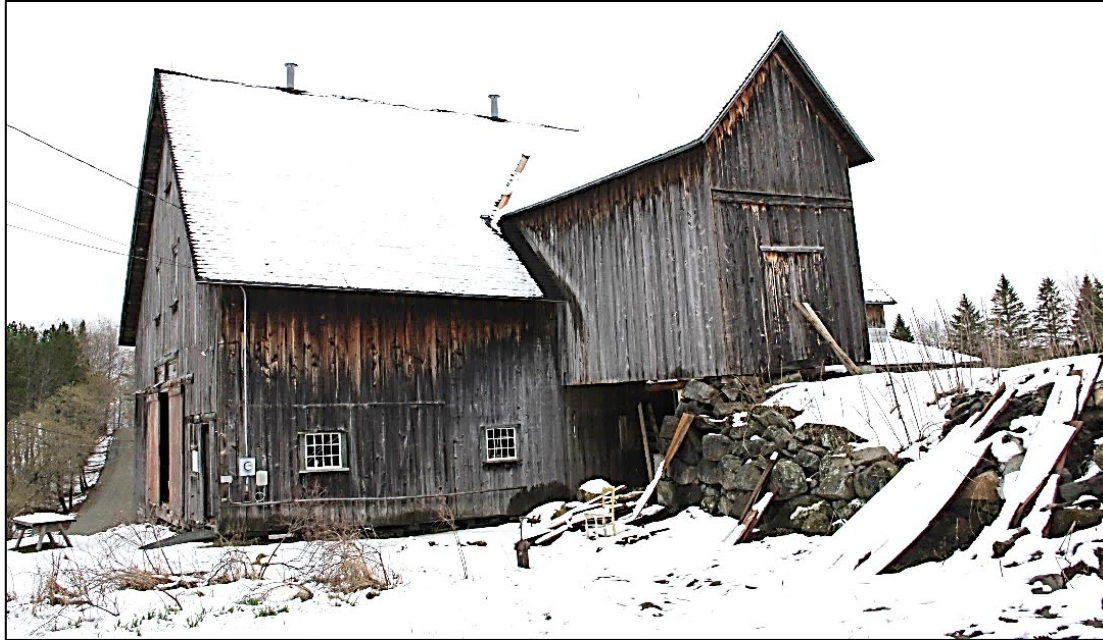
Top: 519 Bragg Hill Road showing two of its three levels and its bridge

The barn at 519 Bragg Hill Road replaced an earlier barn that had burned. Built in 1902, the barn used many of the latest design ideas for modern farming. The ground level had bays for manure spreaders and was also used to house dairy cows, the second level had a hay loft and a separate stable section with windows and more dairy stanchions. The third level was mainly a set of interior bridges for delivering and unloading hay into the two-story mow of the second level. According to the owner, whose father bought the farm in 1930, it was built by itinerant barn builders who also built several others in the area³².

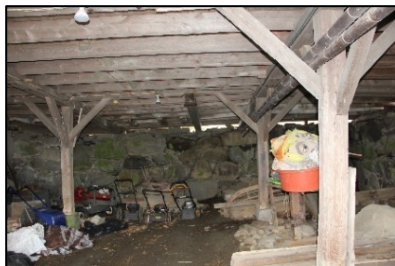
Bottom Left: ground level equipment bay;

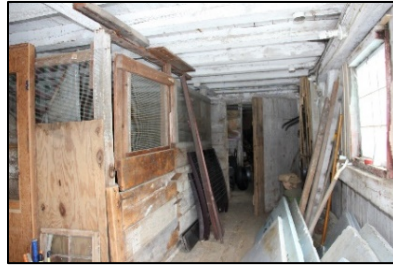
Bottom Center: second floor stable windows;

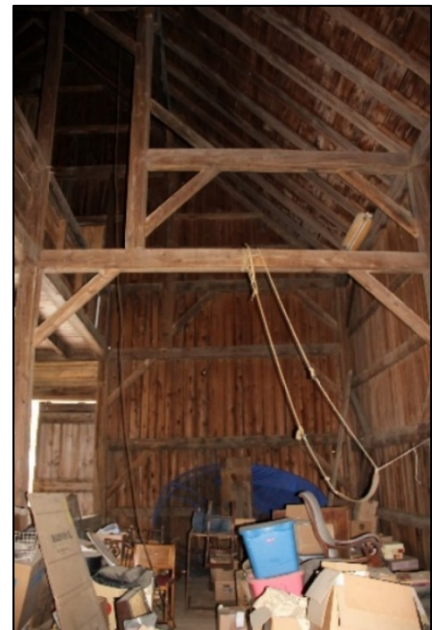
Bottom Right: Second floor hay loft and third floor bridge (on extreme left). This framing has the purlin supported on the tie beam. 2-story posts and a complex of tie beams support the bridge and roof

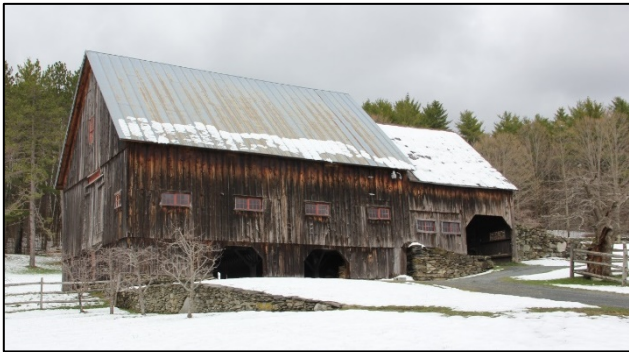
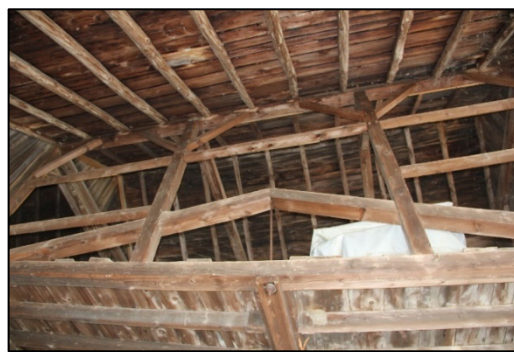
The barn at 1766 New Boston Road is an unusual Bank Barn with an addition that contains both a bridge to the upper loft level and a ramped access to the stable and hay storage level. The large sliding doors at the opposite gable end from the bridge, suggests that at one time the barn may have been an older, ground level Yankee Barn raised up. The barn has complex timber framing to create the bridge level and open lofts below as well as using a king post style truss for the bridge itself. The mostly pegged mortise and tenon joinery with sawn timbers seems consistent between the main barn and bridge addition which makes dating the main barn difficult. There are some reused hewn timbers in the frame as well. While the property was farmed since the eighteenth century, this barn appears to have been built/alterd in the last quarter of the nineteenth century. There is a separate cider mill on the property that also uses older hewn framing members.

Bottom Left: Banked barn with high drive bridge at 1766 New Boston Road; Bottom Right: bridge truss structure of timbers and a metal rod, seen from below

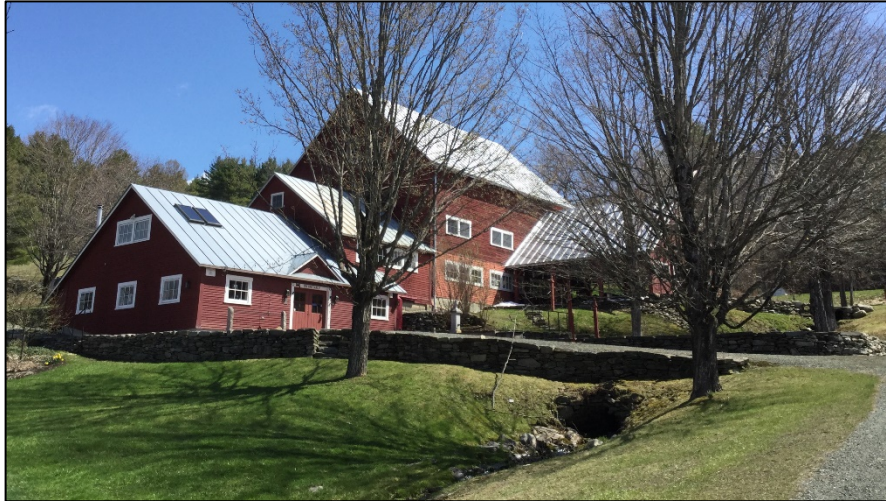
**c. 1895 Late Bank Barn at
430 Upper Turnpike Road**

The c.1895 Late Bank Barn at 430 Upper Turnpike Road has multiple levels as well as additions stepping down the bank. The barn has stable windows. In 1900, the Thorburn family, who likely built the barn, kept twelve to fifteen cows, five to six horses, seventy-five sheep, pigs, and chickens as well as having a large apple orchard. There were some other outbuildings that are not extant but this large barn could have accommodated much of this operation.

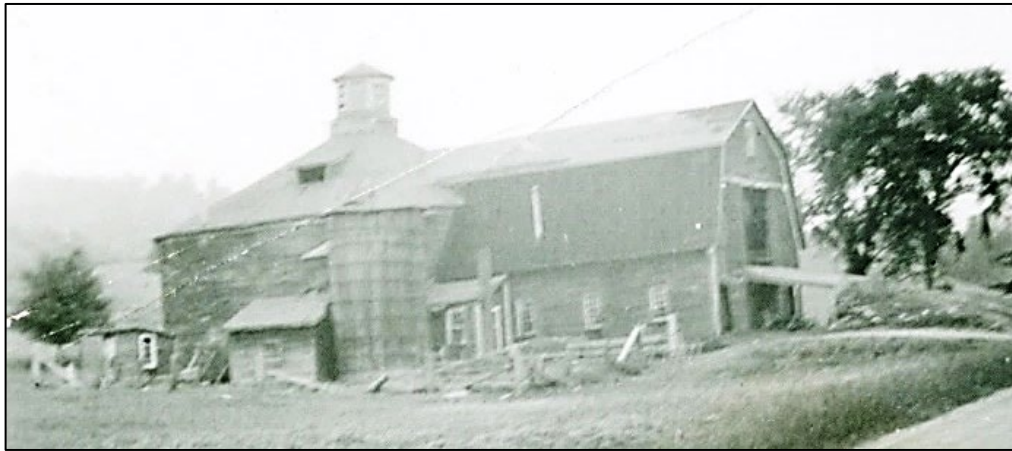
Bottom: c. 1950 view of a round barn at 742 Route 132. (Clark Farm) This ca. 1900 - 1910 barn features a large gambrel roofed bank barn with high drive attached to one side and an early wooden stave silo and feed rooms

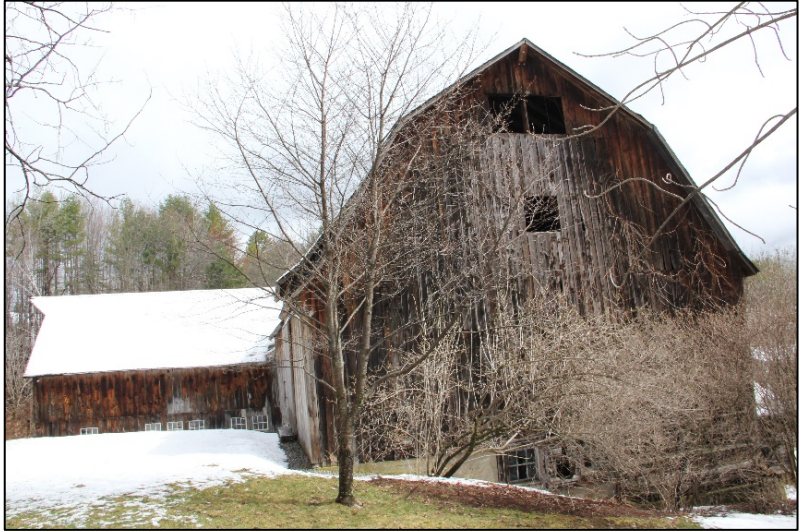
Top: 5 Happy Hill barns with the c. 1929 gambrel; Bottom: another view of 5 Happy hill barns showing other legs of the cruciform shaped floor plan

In addition to the concrete-floored stable with wood stanchions, two different milk houses were added to meet evolving sanitary standards as well as a mechanical gutter cleaner, and eventually a bulk tank. The farm had a silo but it was taken down recently.

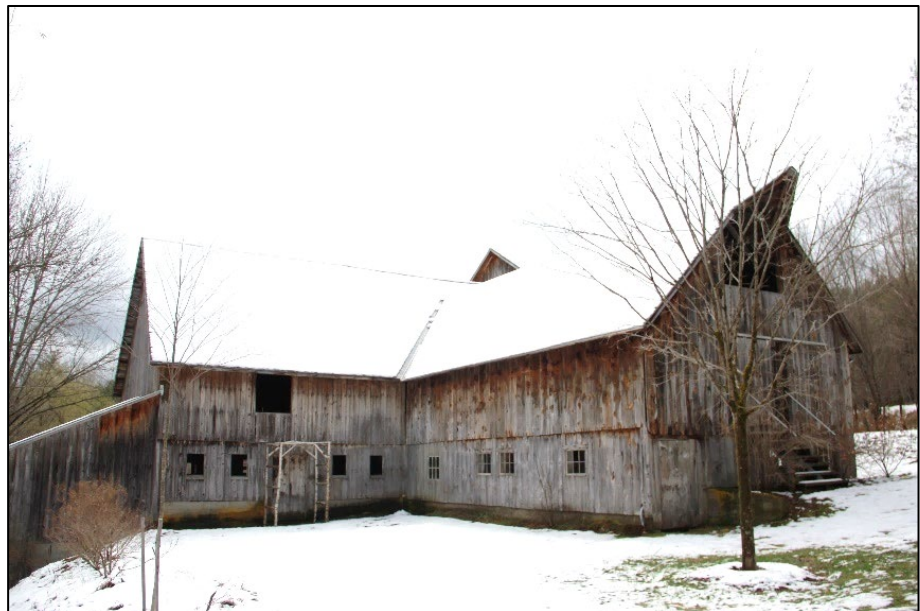
Images of 5 Happy Hill
Clockwise from Above:
Hinged mangers; gutter
cleaner corner mechanism;
older of the two milk houses;
center aisle for dairy stalls;
wooden stanchions

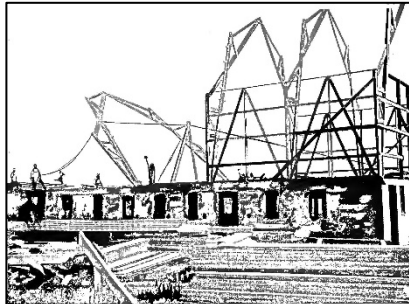
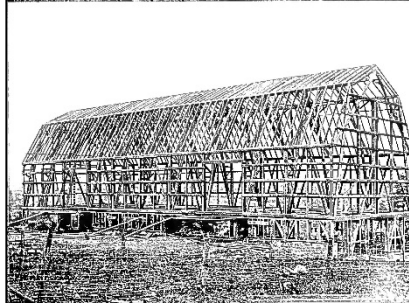
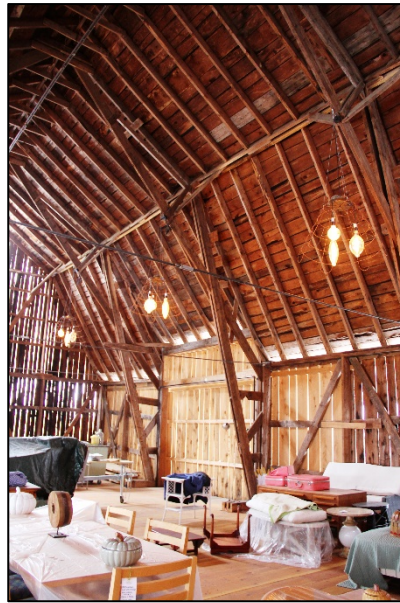
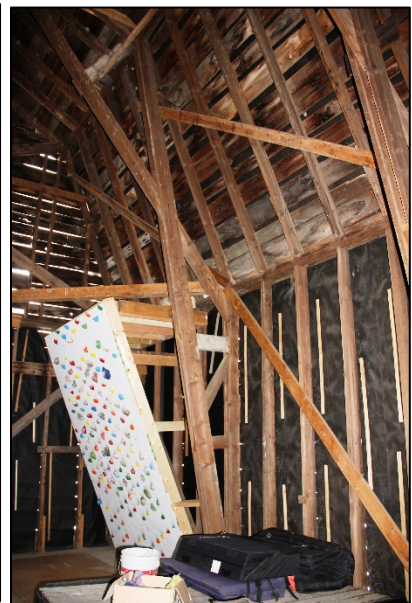
Bottom Left: Photos of erecting the scissors truss type of gambrel roof frame from the Jamesway Co. Catalog of 1918; Bottom Center: Scissors truss in gambrel roof of 5 Happy Hill; Bottom Right: scissors truss at 70 Cossingham gambrel roof

The very tall, gambrel roofed bank barn at 70 Cossingham appears to be an adaptation of an earlier timber framed barn. It appears that an older barn was raised or relocated to a new concrete foundation set into a bank and then was also given a new roof structure. A fire at the farm in 1928⁴⁴, may account for the new barn that utilized older frame components. Modernizing the farm and barn was a topic much covered in the literature and advertising of the day. For example, a 1910 publication entitled *The Farmstead: The Making of the Rural Home and Lay-*

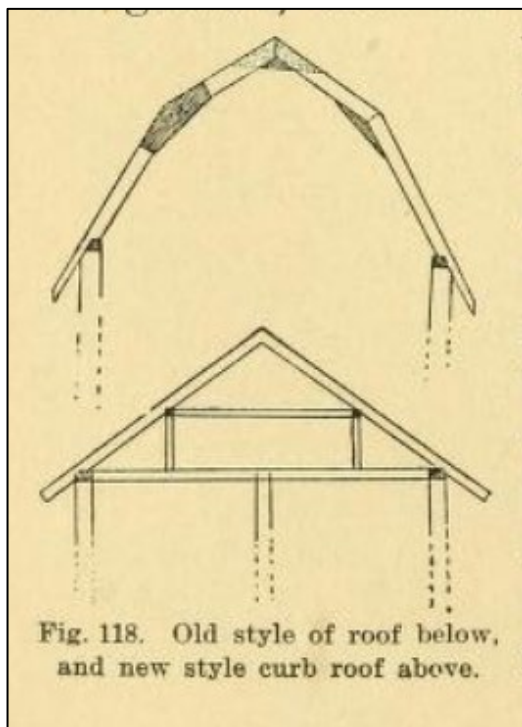
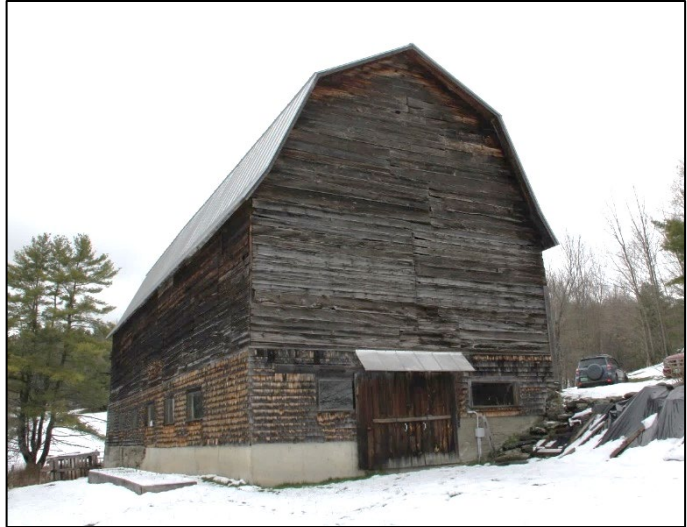
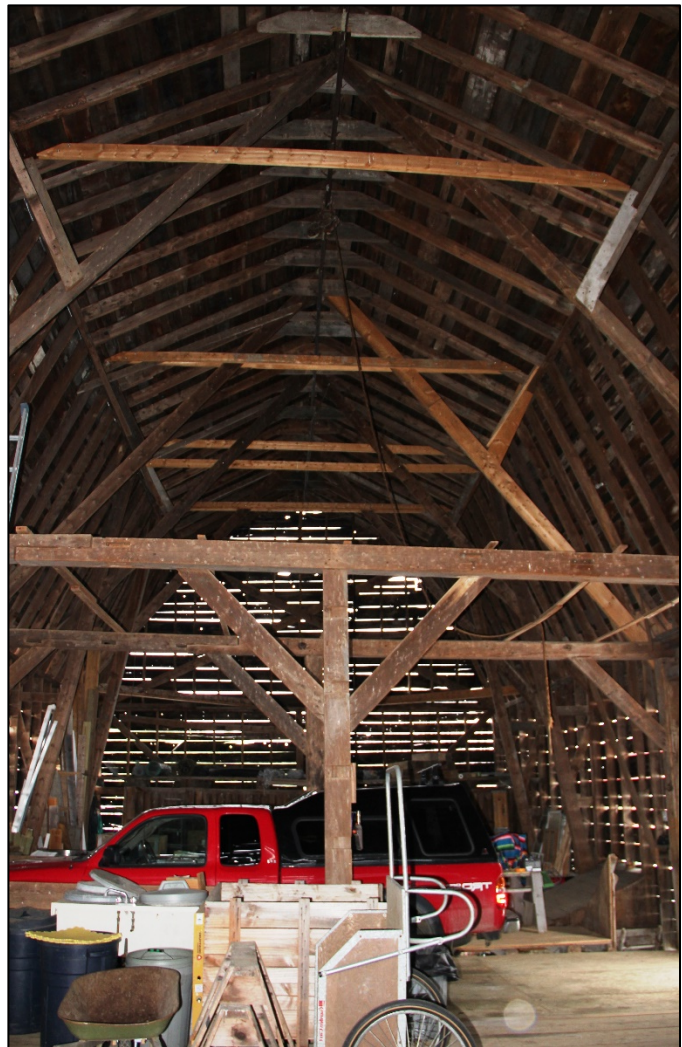
Left: 1910 plate from *The Farmstead* by I.P. Phillips, showing how to convert a gable to a gambrel; Top Right: 70 Cossingham barn with windowless upper levels and concrete basement stable; Bottom Right: interior of hay loft at 70 Cossingham with older timber frame below a more modern scissor truss-gambrel

Out of the Farm, has a section on remodeling the older barn which includes a diagram for changing a gable roof to a tall gambrel.⁴⁵ Richard Cossingham, Jr., whose house and barn dates to 1928-29 after the fire, created this barn around the time of his brother, George's reconstruction project down the hill and used an old timber frame as the basis for this barn. The scissors truss gambrel roof is nearly the same as his brother's new barn. The result is a functional, concrete basement level stable with a drive-in upper hay mow. The stable level has concrete gutters behind the raised stalls and a large concrete trough with spigot where water could be run to keep milk cans cool.

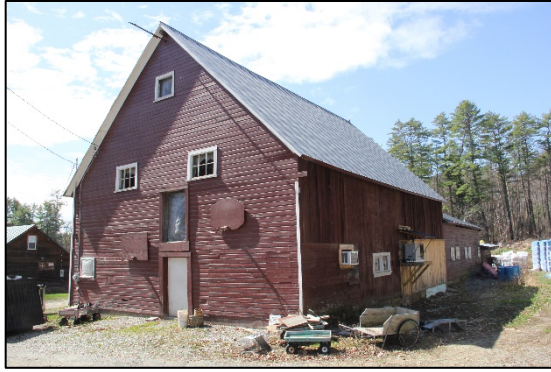
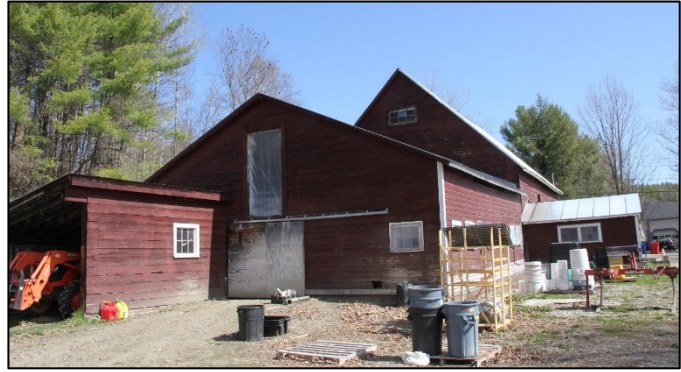
Top Left: Yankee Barn at 55 Butternut Road with 20th century dairy barn extension; Top Right: 55 Butternut ca. 1935 ground level stable attached to the older barn, with newer equipment shed on left and attached, c. 1960s milk house on right

There is an example of a mid-nineteenth century ground level Yankee Barn at 55 Butternut that was later adapted in ca. 1935 for dairying with the addition of a Ground Level Stable barn. A milk house addition was also later added.

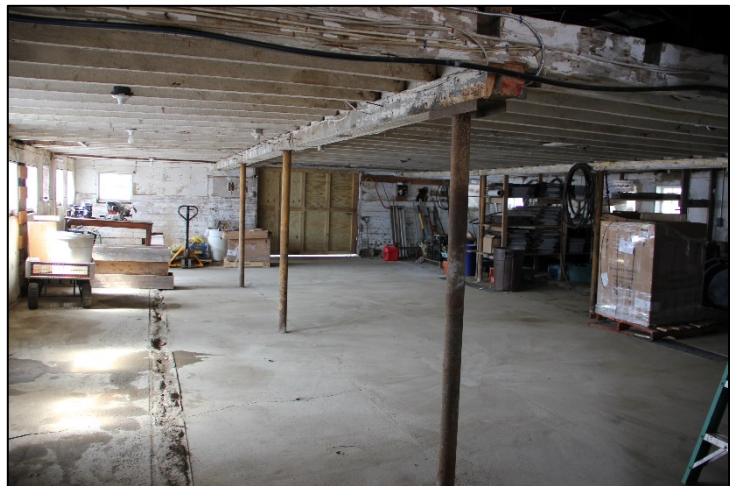
Center: Interior of 55 Butternut showing well-lit, newer stable with concrete floor, former gutters, and drive-in large bay door;

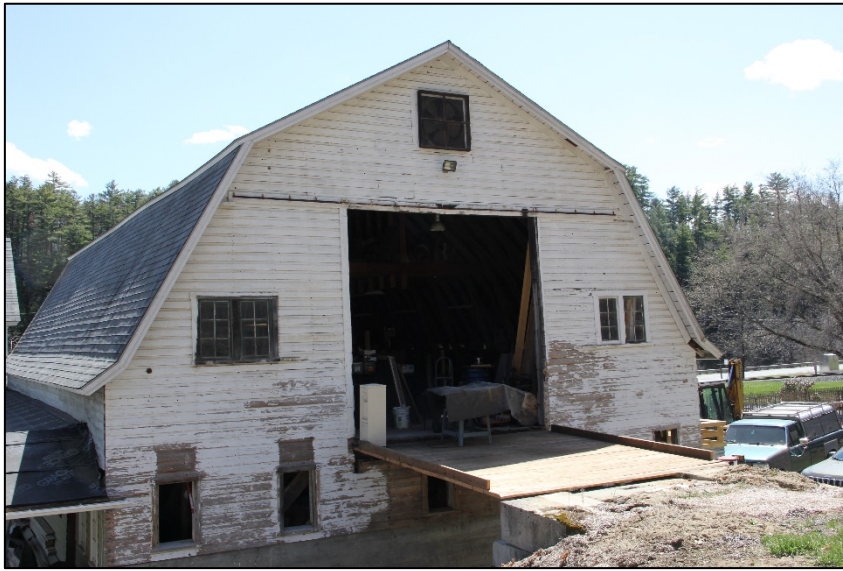
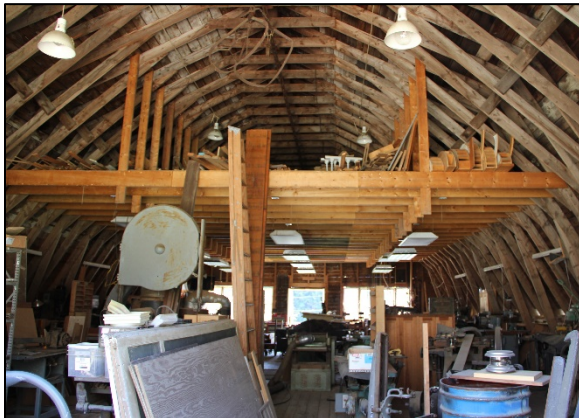
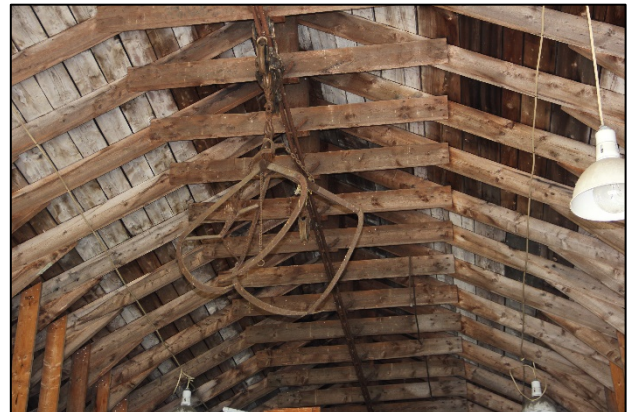
Top Left: open bridge high drive of Ground Level gambrel-roofed stable barn at 255 River Road (Melendy Farm); Bottom Left: stick gambrel roof framing in 255 River Road barn; Bottom Right: Hay fork and track at 255 River Road

The 1939 dairy barn at 255 River Road (Melendy Farm) is a hybrid of the Ground Level Stable and the Late Bank Barn. According to the current owner, it replaced an earlier bank barn on the site. The 1939 barn has a bridge high drive on the rear allowing windows below to light the concrete-floored stable but with drive-in access to the hay loft. This may well have been a kit barn. The roof framing was planned with a hay fork and track system in mind with its high cross braces at the peak. The system is still in place.

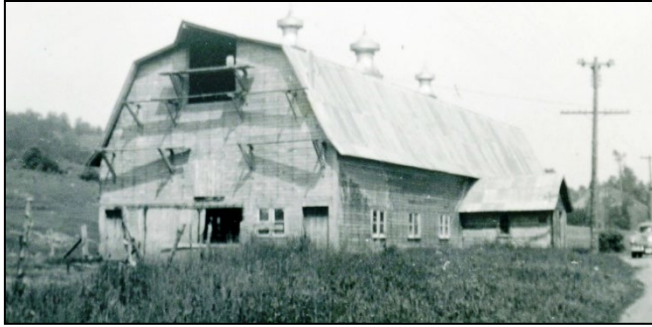
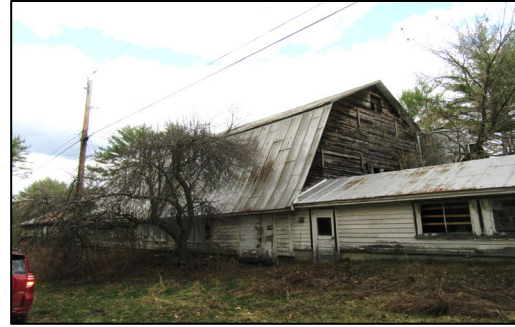
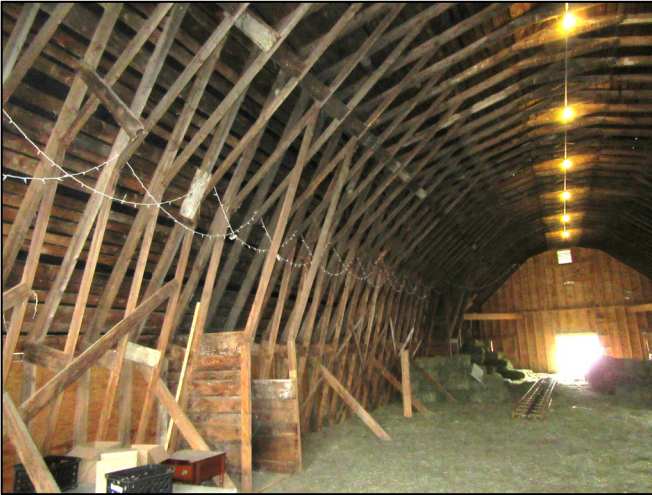
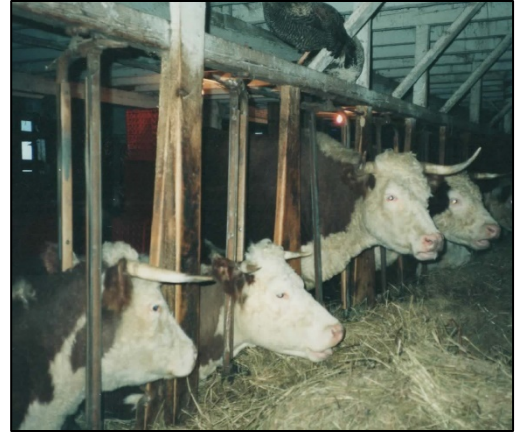
Top Left: ca. 1950 lister photo of the newly re-located Ground Level Stable barn at 752 Route 132 (Clark Farm) showing its original metal roof ventilators, stable windows, extended roof peak to protect the hayfork machinery; and its attached milk house; Top right: The ca. 1939 Thetford gambrel roofed barn of Roy Clark's brother; Bottom Left: The stick framing of the gambrel roof at 752 Route 132; Bottom Right: The original metal cow stanchions.

The Ground Level Stable barn was the main innovation in barn design of the first half of the 20th century. There are several examples in Norwich of this style of barn. A good example of the type is at 752 Route 132 (Clark Farm). This barn was originally built ca. 1939 in Thetford. It had to be moved for the construction of the Union Village Dam in about 1950 and was relocated to 752 Route 132 by then owner Roy Clark. Per the c. 1950 lister card photographs, an older, deteriorated round barn was also on this farm while the new, relocated barn was being fitted up.

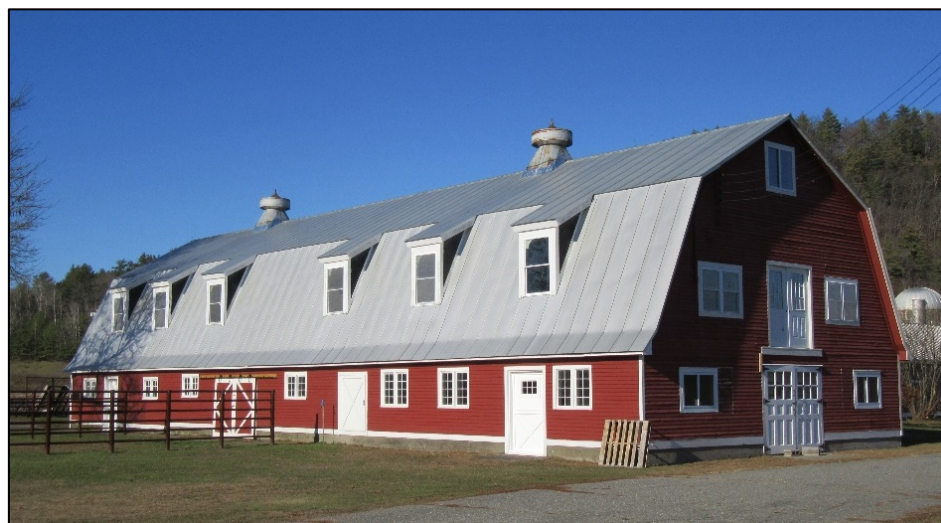
Top: 2021 Google satellite image of the Starlake/Farrell Farm and surrounding fields; Center: one of the gambrel roofed Ground Level Stable barns; Bottom: Farrell Farmstead showing milking/stable barns and silo.

The barns, silo, and sheds are still intact, though some may have been re-purposed. It is not only the best example of this barn and farmstead type in Norwich, it may well be one of the best in the state. It is not currently being farmed.

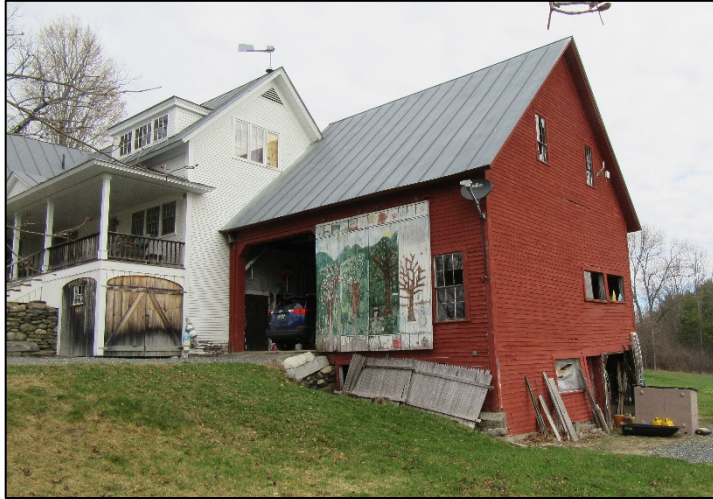
Attached Bank Barn at 198 Dutton Hill Road

Another barn created in the mid-20th century worth mentioning is the attached small bank barn at 198 Dutton Hill Road (now Griggs). Although the house, just below the large 218 Dutton Hill Road farm, (Dutton/Metcalf) doesn't specifically appear on the 1869 Beers map, the house is reportedly ca. 1850. The attached barn is quite intact and a great example of the barn as a tool. This barn, with some older (pegged and hewn) and some newer (sawn and nailed) framing, was built against or brought to the side of the existing house. The present owner thinks it was assembled of older parts in c.1940

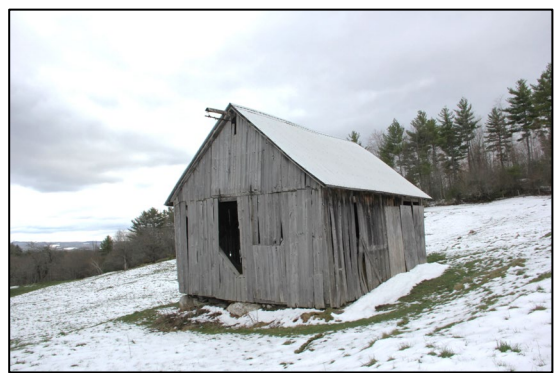
**1942 field hay barn at 136 Bradley Hill Road
(Langlois Farm)**

There are examples in Norwich of specialty barns such as a Machine Shed/Pig Barn built in 1942 at 136 Bradley Hill Road. The barn has a boiler and chimney for heating slop, pens on the ground level, built-in grain bins on the road level with equipment bays, and a manual freight elevator. Also at this farm are a 1942 field hay barn, made in part of salvaged lumber, where hay could be stored near where it was cut, and a modern free-stall steel pole barn built in 2004 for the current owner's Hereford beef operation.

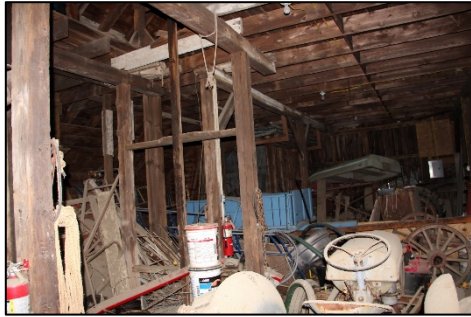
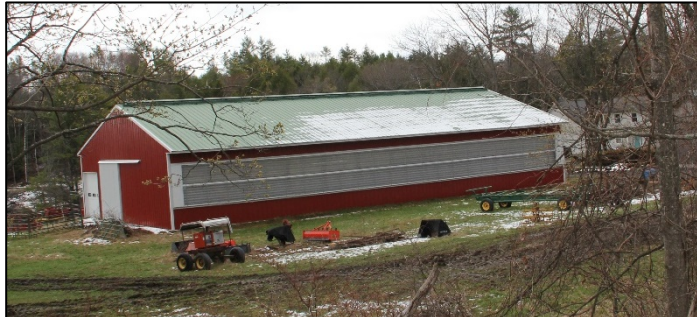
Top Left: Manual freight elevator in 1942 machine shed/pig barn; Top Right: 2004 free-stall pole barn for beef operation

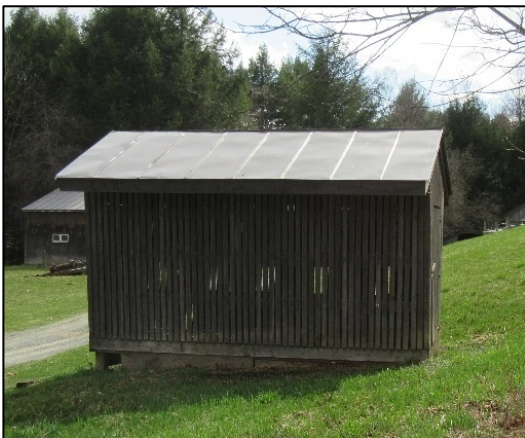
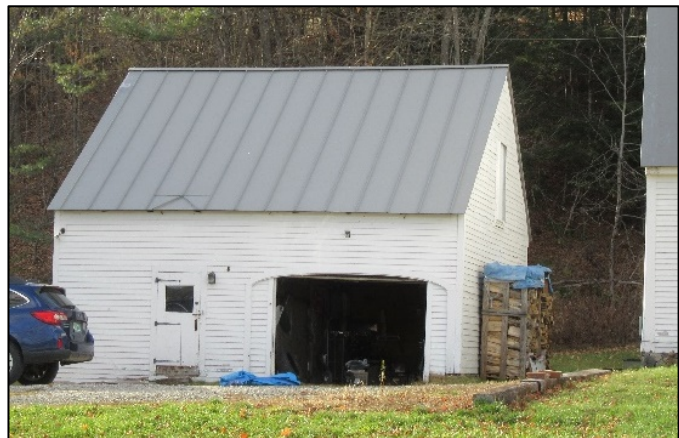
Center Left: Corn crib at 97 Kerwin Hill Road; Center Right: Detached shed at 655 Route 132 may be an earlier sheep or wagon shed.

Like the field hay barn, a corn crib is a specialty structure for feed. There is a modern example at 97 Kerwin Hill Road. An example of an early wagon shed or possibly small sheep barn, with its wide-open shed is at and a more modern corn crib are other specialty structures found in Norwich. There are examples of an early twentieth century and a current horse barn at 24 Academy Road and 288 Hogback Road (Pirouette Farm).

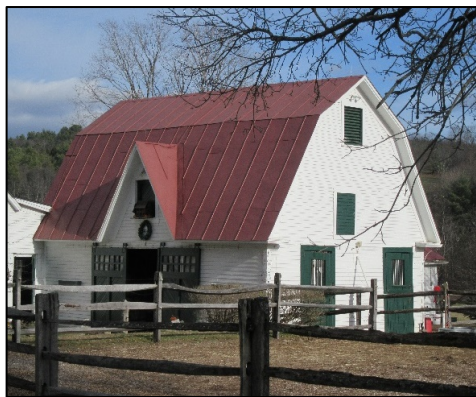
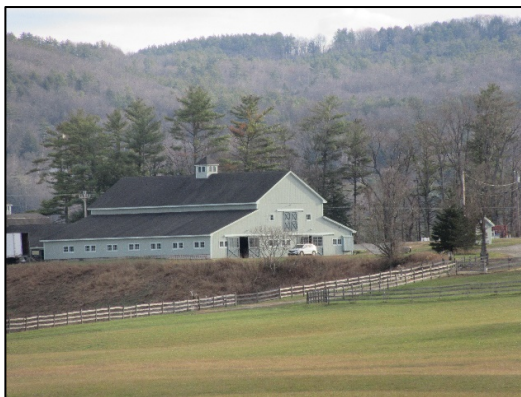
Horse barns, Bottom Left: ca. 1900 24 Academy Rd; Bottom Right: c. 2000s, Pirouette Farm, 288 Hogback Road

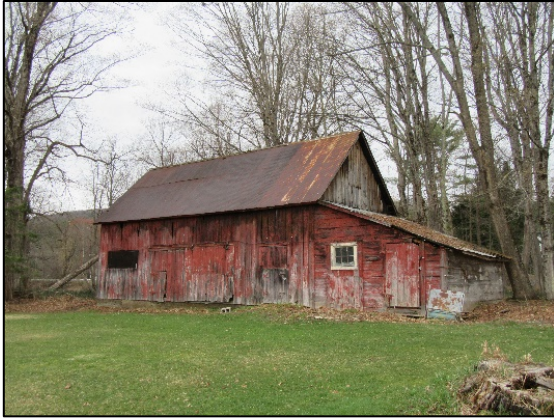
Top Left: Parker slaughterhouse, near 70 Beaver Meadow Road; Top Right image of Glen Parker at his farm at 395 Main Street with his steers (from *Norwich, Vermont: A History*, p. 130).

Part of ca. 1925 slaughterhouse remains on the edge of Huntley Meadows, behind the church at 70 Beaver Meadow Road. Glen Parker ran this slaughterhouse along with his meat business and had his own farm at 395 Main Street which included meadows and pasture between Main Street and Beaver Meadow Road. Parker raised animals for his meat business and also bought animals from Norwich farmers. He retired in 1957 and sold much of the land, some of which was developed with houses as Huntley Road.

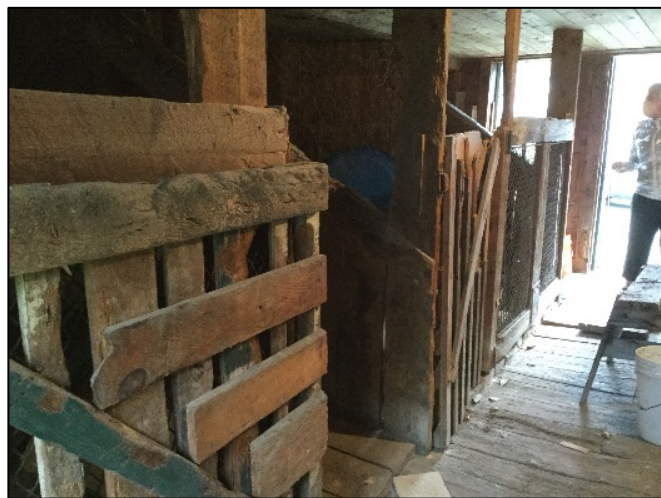
Within the village of Norwich are many examples of attached and detached barns, carriage barns, wagon sheds, and workshops. The recent survey of thirty-four properties with these structures by the NHPC members, shows that a number of these have been modernized and some repurposed as living or office space. However, there are also some examples of intact features from a horse-based time, such as horse stalls in an attached shed/barn at 19 Church Street.

Bottom: 19 Church Street horse stalls

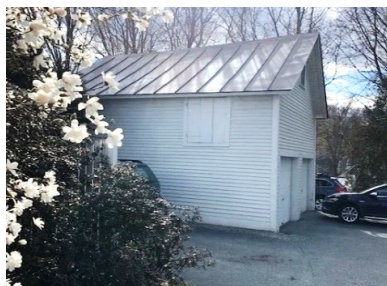
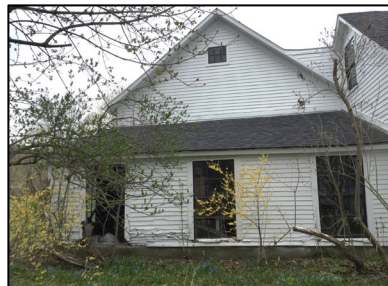
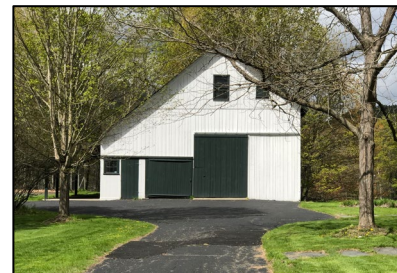
Bottom Left: Carriage Barn at 27 Beaver Meadow Road; Bottom Center: Former henhouse at 19 Church Street; Bottom Right: Large in-town Barn at 395 Main Street
