NORWICH BARN SURVEY 2021

NORWICH HISTORIC
PRESERVATION COMMISSION

LYSSA PAPAZIAN
HISTORIC PRESERVATION CONSULTANT
13 DUSTY RIDGE ROAD, PUTNEY, VT 05346
www.lyssapapazian.com ~ lyssa@lyssapapazian.com
(802) 536-5262 / (802) 579-3698 CELL

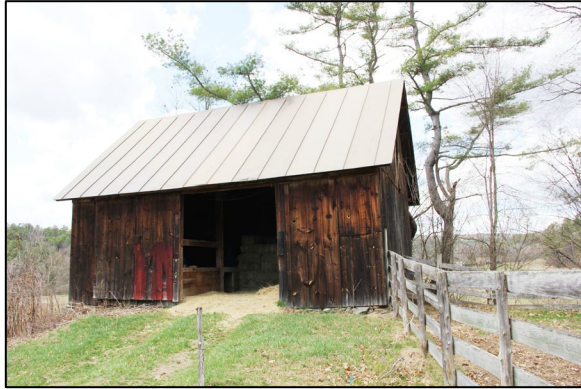
Left: Early English/Bank Barn at 98 Campbell Flats Road; Right: Late Bank Barn at 287 River Road

An excellent example of an early English style barn, that was likely later made into a bank barn, is at 98 Campbell Flat Road. Its roof framing of principal rafter with common purlins (rather than the opposite) is an early form that was found in Southern New England but not common in Vermont. The late eighteenth century, scribe rule frame is sophisticated using gunstock posts and the English Tying Joint which may indicate that it was made by itinerant professional framers, like Broughton and Carpenter. The framing of the manure basement level, has sawn timbers suggesting it was a later addition when the older barn was moved to a sidehill to create the lower floor.

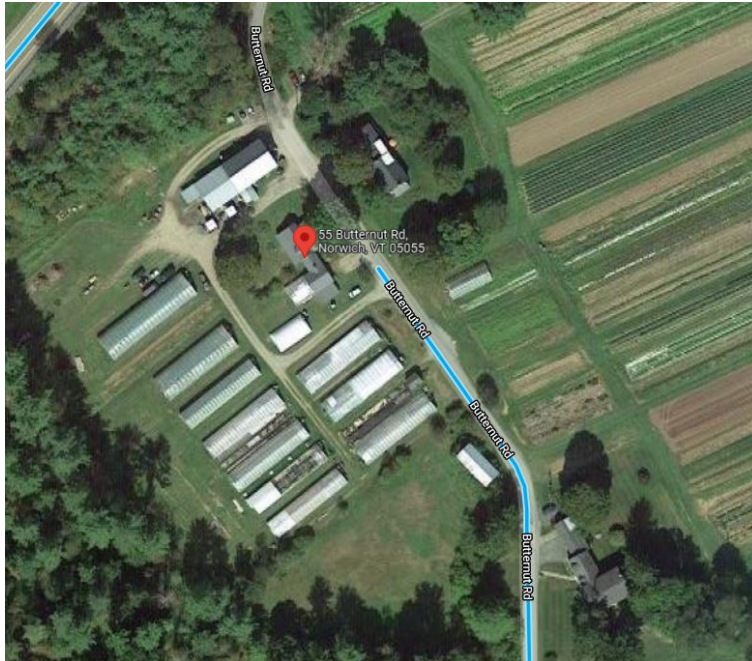
The major threats to historic barn preservation are twofold. On current farms, the investment in maintaining older buildings, must be financially feasible as part of the ongoing business. An example of adaptive re-use that serves a modern farm is at Honeyfield Farm where a cold storage facility for vegetables was built within part of the older dairy barn. Necessary adaptations can be

Top: Satellite view of Honey Field farms showing the under-used old barn at the top along with the many modern greenhouses and cropped fields.

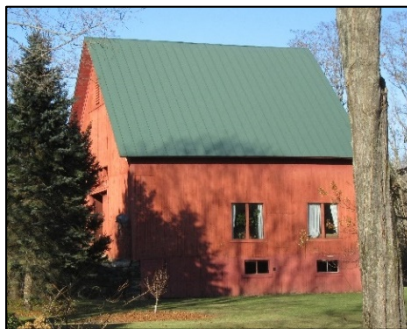
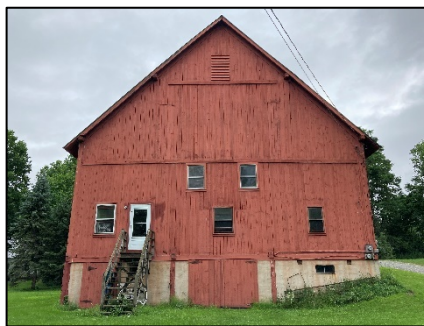
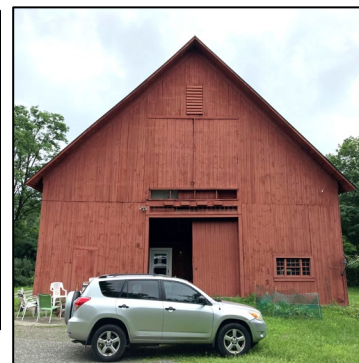
Bottom photos: Barn at 8 Old Bridge Road (former Waterman farm) adaptively re-used as an apartment but retaining its historic barn character.
